CRREL REPORT 98-3

# Structural Analysis of DEW Line Station DYE-2, Greenland

## 1983–1988

Michael R. Walsh and Herbert T. Ueda

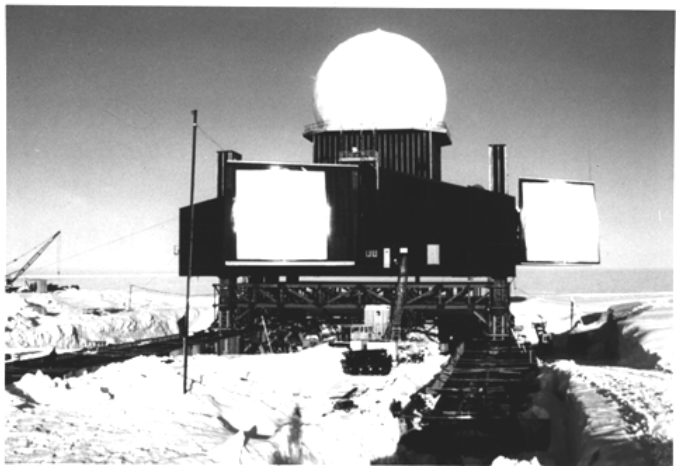
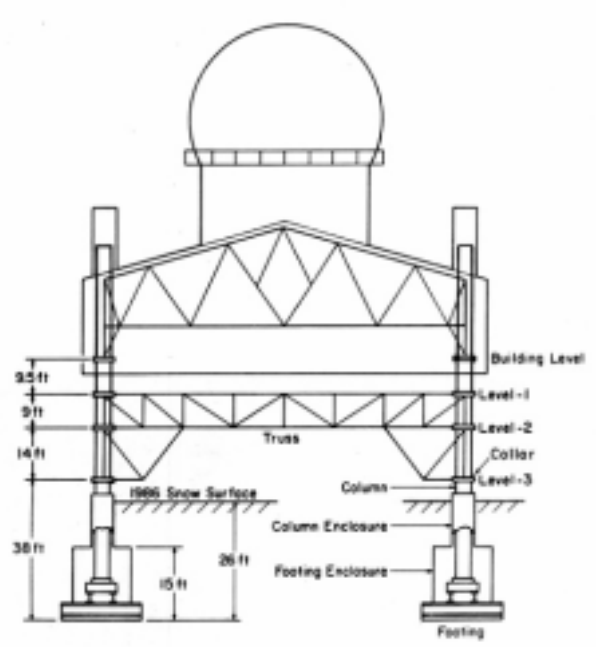
*Figure 4. DYE-2 move: 1982.*

By the early 1980s, measurements indicated that column stresses were sufficiently high to require drastic remedial action. In 1982, the supporting structure was severed at a new base level, and DYE-2 was moved sideways 64 m onto a new set of footings (Fig. 4). The following year, the building was lifted 8.2 m. Since that time, CRREL personnel monitored building and col-

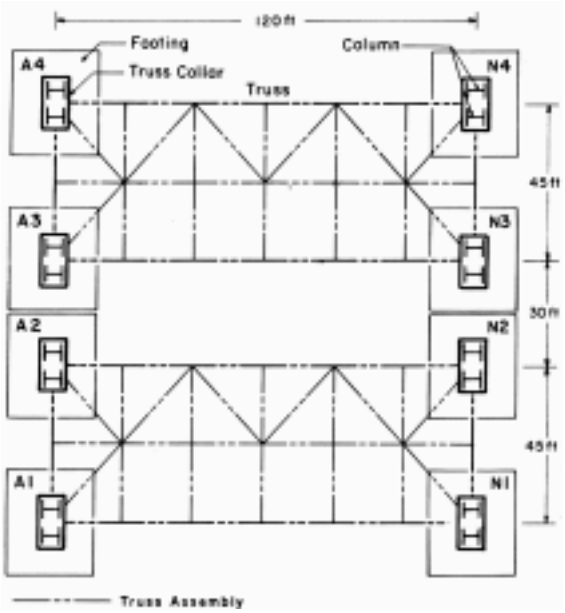
*Figure 6. Footing–column–truss system: plan view.*

DYE-2 is a steel composite building supported by eight columns at the second floor level by a system of modified Warren trusses (Fig. 5). Below the building but above the snow surface are two truss systems that surround four columns each (Fig. 6). The trusses interact horizontally with each column through a series of three collars (Fig. 7). Within these collars and at the building collar located at the level, the columns and confining trusses interact through an array of sway bolts, which act like setscrews against different faces of the columns (Fig. 7 and 8). The truss system is vertically supported at the lower collar on steel channels welded to the columns. Friction-reducing Teflon-on-stainless-steel bearing pads are located between the supporting channels and the lower collars of the trusses. The complete support system finally rests on the snow through support blocks and large timber footings at the base of the columns (Fig. 9).

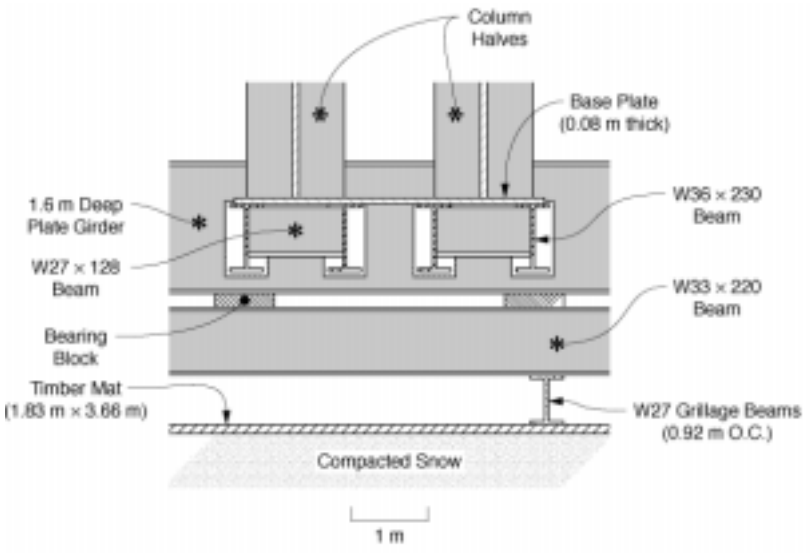
*Figure 9. Column footings.*

Differential settlement of the column footings is caused by differences in densification rates of the foundation snow beneath each column footing. At DYE-2, the snow was not of uniform consistency because of the presence of ice lenses of various sizes and thicknesses imbedded in the matrix of the snow. These “defects” were formed by snow melting and refreezing during the warm summer months and subsequent burial beneath drifted or fallen snow. Matrix density irregularities cause differences in the densification rate for a given load, and thus settlement irregu-

larities can occur beneath different columns. A column that settles more rapidly on its snow foundation will not support as much load as the adjoining columns, which then must assume a portion of the sunken column's load. Continued settlement will result in structural tilting and a redistribution of stresses. This results in increased stresses in the structure because of uneven loading and tilting.

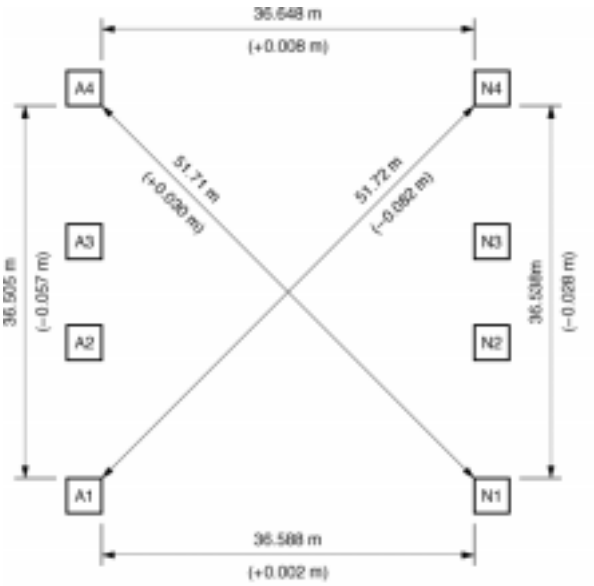
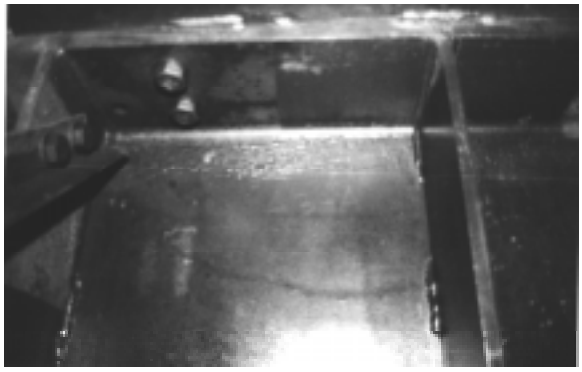
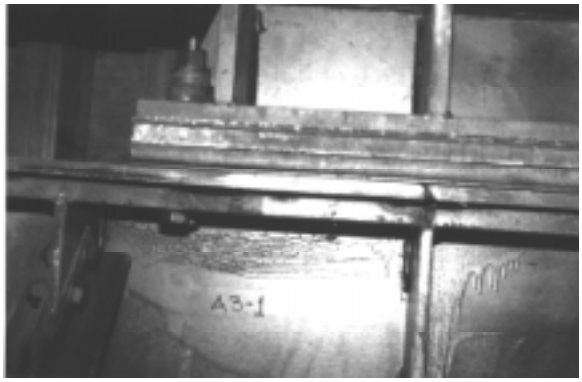
Finally, as the footings settle and the ice cap drifts (App. A), the columns move differentially with respect to each other (Fig. 10). This differential movement, in addition to the column out-of-plumbness mentioned above, sets up horizontal distortions in the column–truss system that can result in high loads at restraining points at the collars and in the building. High bending moments at the column bases are a result of these large horizontal loads. The horizontal distortion of the truss system may also be the reason why pinching and spreading loads sometimes appeared during sway bolt measurements (described in

*Figure 10. Horizontal movement of columns at snow surface.*

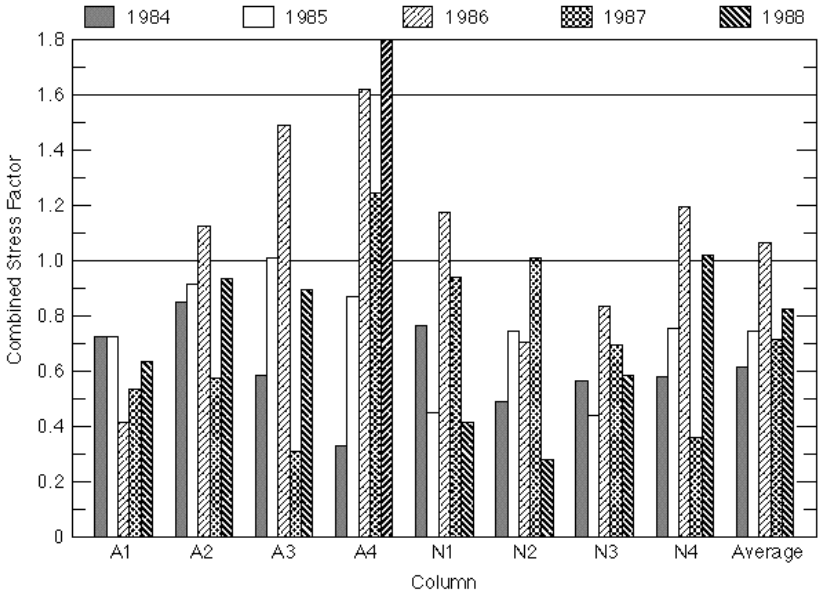
*Figure 12. Summary of base level stress concentration factors: 1984-1988.*

low, with an average base level combined stress factor (BLCSF) of about 0.61. BLCSFs are calculated loads on the column bases caused by stresses measured in the four collars of each column. There is no obvious pattern to the stress levels. None of the column BLCSFs exceed 1.00. In 1985, the stresses have become redistributed. The average BLCSF has increased to 0.71, with one column exceeding 1.00. Again, no pattern is obvious, although the A row is more heavily loaded than the N row.

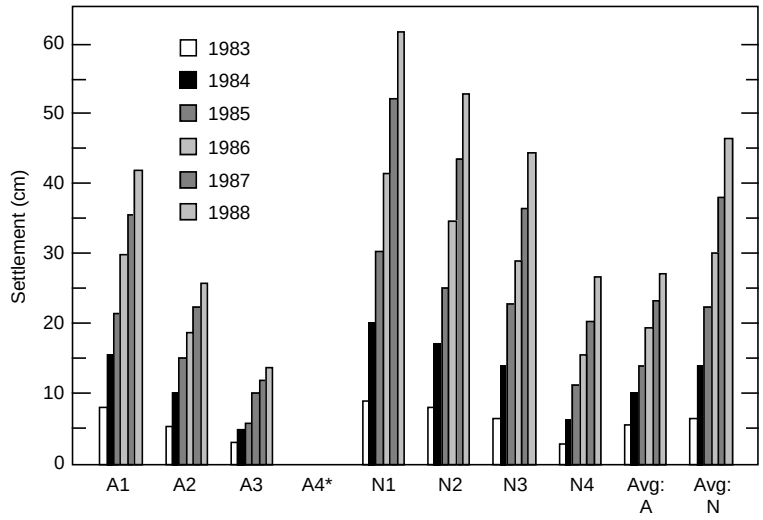
*Figure 13. Footing settlements: 1982–1988.*

at differing rates. Figure 13 shows the settlements of the A and N row of columns, as well as the averages of each respective row. Footing A4 was used as the datum point as this was the slowest settling footing and was used as the "baseline" footing previous to the move in 1982. Therefore no settlements are given for it.

From these figures, several observations can be made. The most obvious is that the N row is settling faster than the A row. The average rate of settlement of the N row with respect to A4 is 0.08 m/year. The settlement of columns A1 through A3 with respect to A4 is only 0.05 m/year. Footing settlement data can be found in Walsh (1992).

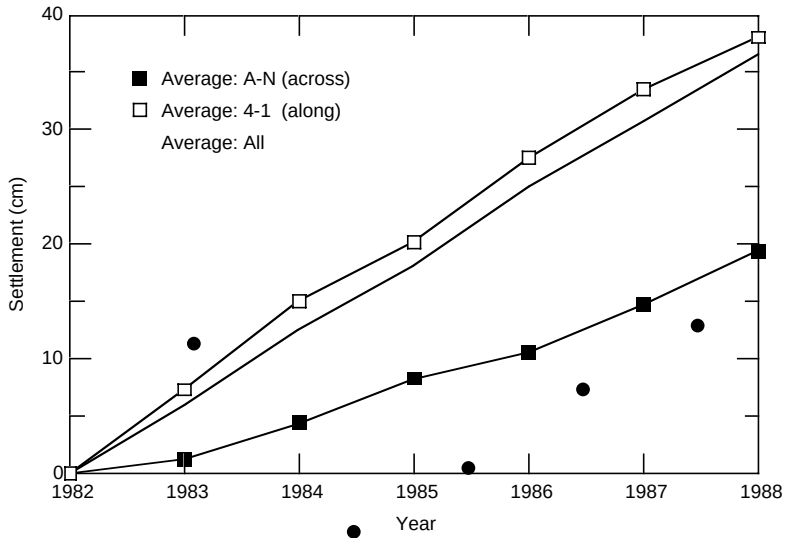
*Figure 14. Footing settlement trends.*

The across-row settlement as well as the along-row settlements for both rows show similar trends. Figure 14 shows these settlements for the years 1982 to 1988. Along-row settlements were normalized to A4 and N4 for their respective rows while across-row settlements were normalized to the A row. One important note to make here is that in August of 1988 approximately 2 m (6 ft) of water and ice was present in footing N1 (Fig. 15). This was an accumulation of over a meter (4 ft) since June of that year. The effect of the presence of this much water in the column footing may have led to weakening of the underlying packed snow foundation or even voids, depending on the amount of heat given off during the transformation of the water to ice and the contribution of the structural members within the footings to the dissipation of this heat. As the mean annual temperature at DYE-2 is around –16.6°C, there is a good chance some melting of the foundation may have occurred. However, with no borings conducted to verify this hypothesis, we can only postulate that the foundation was adversely affected by the presence of this water.

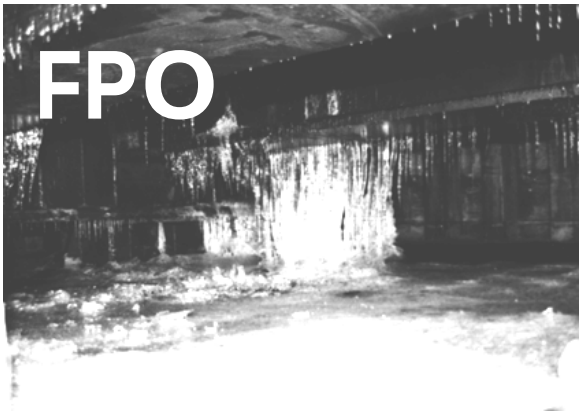
*Figure 15. Flooding of footing N1, August 1988.*

base level column load can be found in the opposite corner, at column A4. The presence of a large quantity of water at the base of column N1, covering the footing to a depth of several meters, indicates melting of surface and structural snow and subsequent runoff and collection in the column enclosures. These factors may indicate the cause of the tilt problem at DYE-2: changing snow conditions at the base of the "warm" side footings due to the presence of meltwater. Warmer conditions and the presence of water at the bases of these columns would cause melting or increased densification of the snow beneath these footings, which in turn would undermine the support these columns contribute to the structure. This would contribute to or even cause the differential settlement rates, column and footing tilts, and stress distribution patterns found at DYE-2.

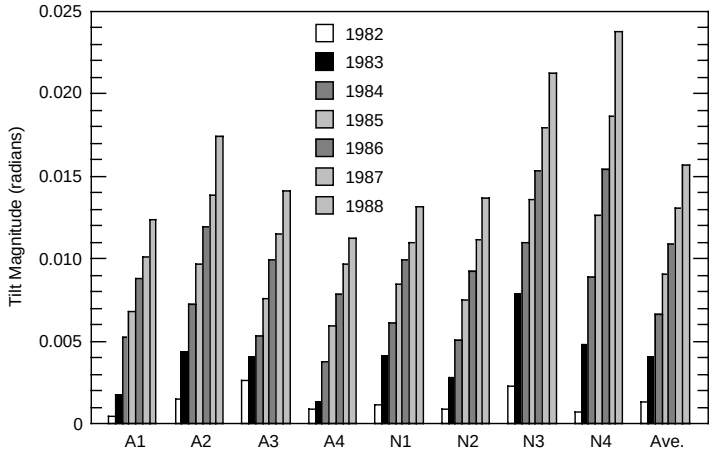
*Figure 16. Footing tilts: 1982-1988.*

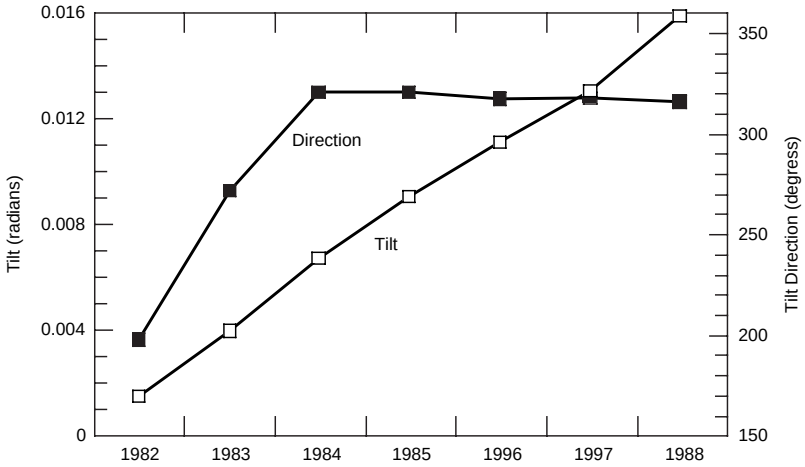
*Figure 17. Footing tilt trends.*

ern corners (A4 and A2), with the rear truss system (the A4 system) the more heavily loaded. This ultimately affects the base level stress factors.

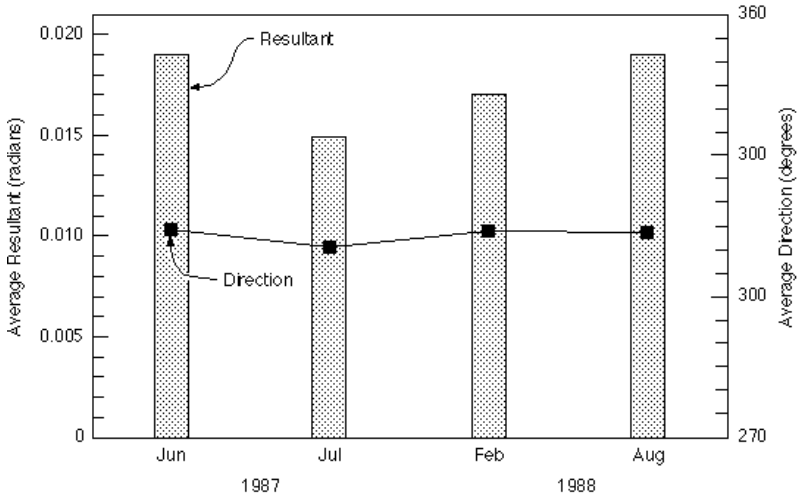
*Figure 18. Column tilt trends.*

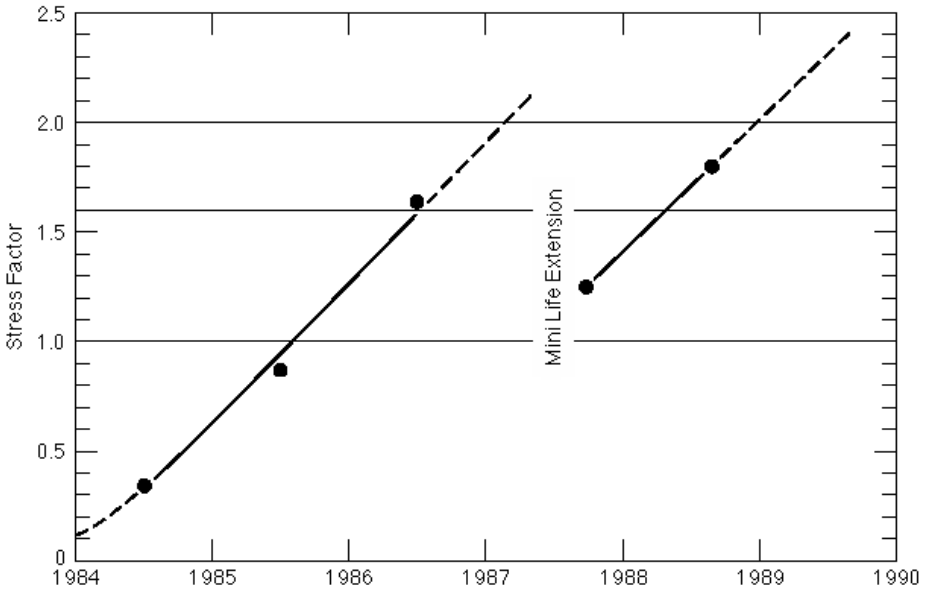
*Figure 20. Extrapolation of base level combined stress factors for column A4.*

not done. From the data, one can see a rise in the general state of stress in the structure, especially in column A4, which has a combined stress factor well in excess of 1.60. Extrapolation of this and previous years' data indicated a combined stress factor of more than 2.00 by year's end (Fig. 20).

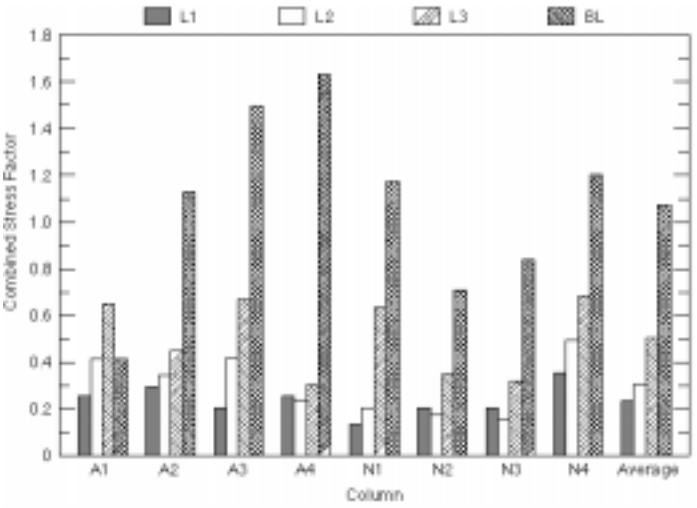
Figure B4 contains the third complete set of combined stress factors since the move in 1982. It is interesting to compare stress factors for 1984 through 1986 for trends. High stress concentration factors in general, and especially at column A4 (>1.60), led to a recommendation that work be contracted for the next summer to alleviate some of the high stresses. Column tilts were also a factor in this decision.

*Figure B4. Swaybolt loads: 1986.*

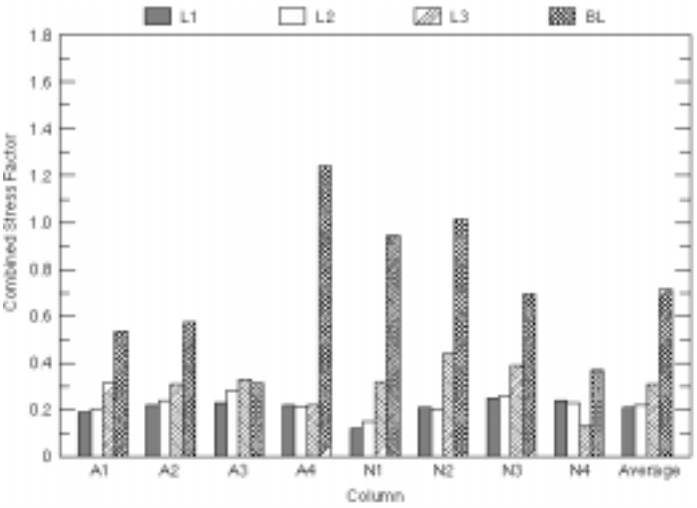
Figure B5 contains the fourth complete set of combined stress factors since the move in 1982 and the first since the mini-life-extension of 1987. Comparing stress factors for 1984 through 1987 points up several trends that are more obvious when examining Figure 12. Although the mini-life-extension served to lower most stress and redistribute stresses among the columns in general, trends dictated a repeat of the work performed in 1987 to assure the structural integrity of the building. Another mini-life-extension was therefore recommended for 1988.

*Figure B5. Swaybolt loads: 1987.*

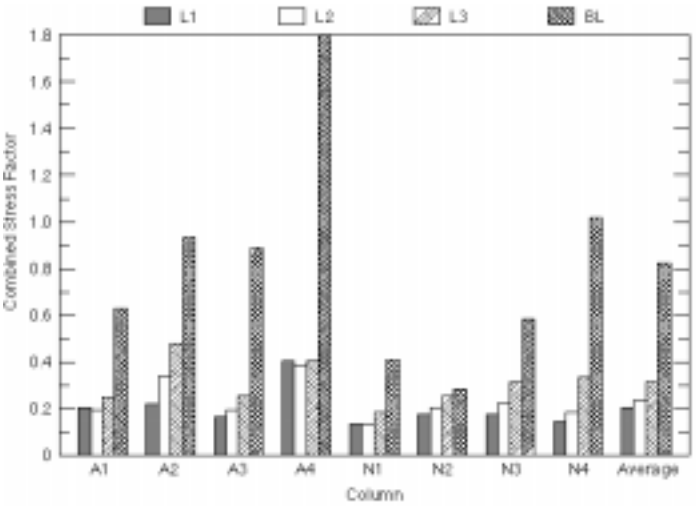
Figure B6 contains the final complete set of combined stress factors calculated for DYE-2 and the second since the mini-life-extension of 1987. Comparing stress factors for 1984 through 1988 points up several trends which are more obvious when examining Figure 12. Although the mini-life-extension was recommended for the summer of 1988, funding difficulties were encountered and the work was

*Figure B6. Swaybolt loads: 1988.*
